Phase One Environmental Site Assessment (ESA)

Black Bear Ridge Golf & Resort 449-501 Harmony Road, Corbyville

Project # 2200902

August 2, 2024

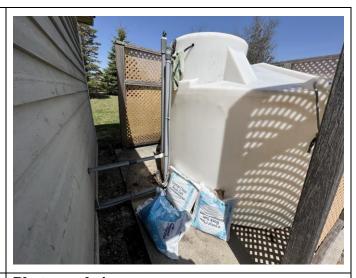
Photo depicts the water filter shed

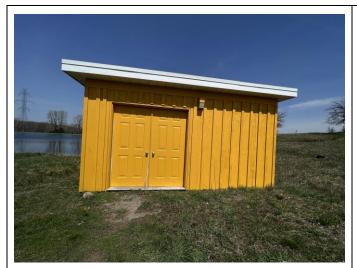
Photo depicts the shed located close to the cabins

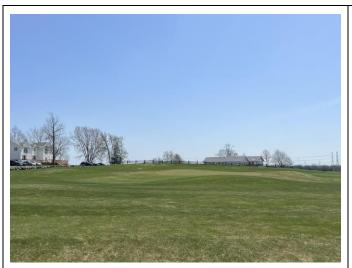
Photo depicts a general view of the golf course
