Hydrogeological Assessment Proposed 2-Lot Severance at 287 Kelly Road Foxboro, Ontario

Project 23-3-8491

Hydrogeological Assessment for Proposed 2-Lot Severance at 287 Kelly Road in Foxboro, Ontario

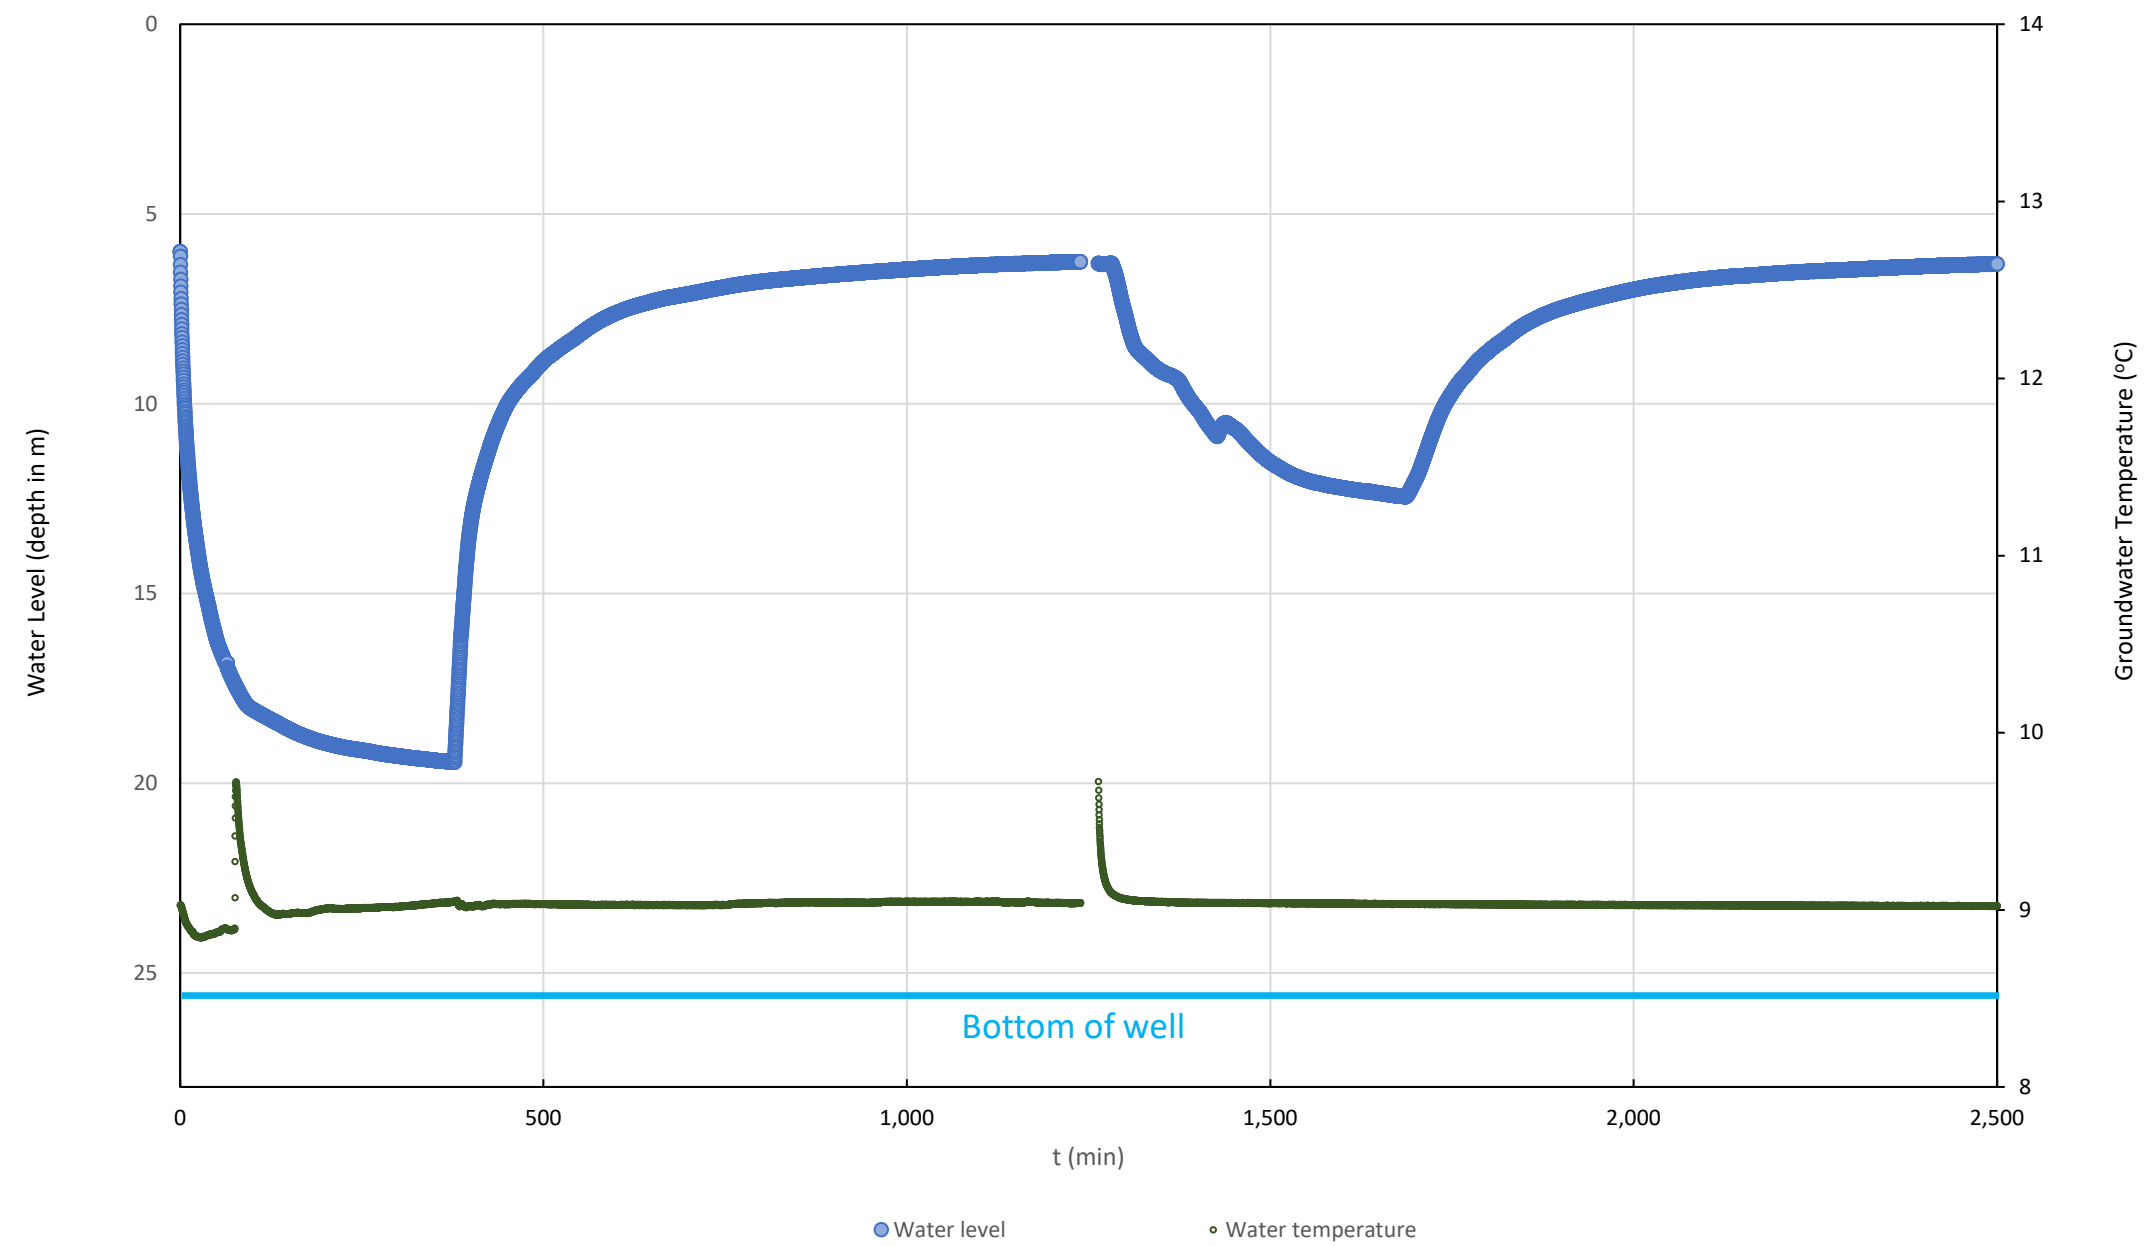
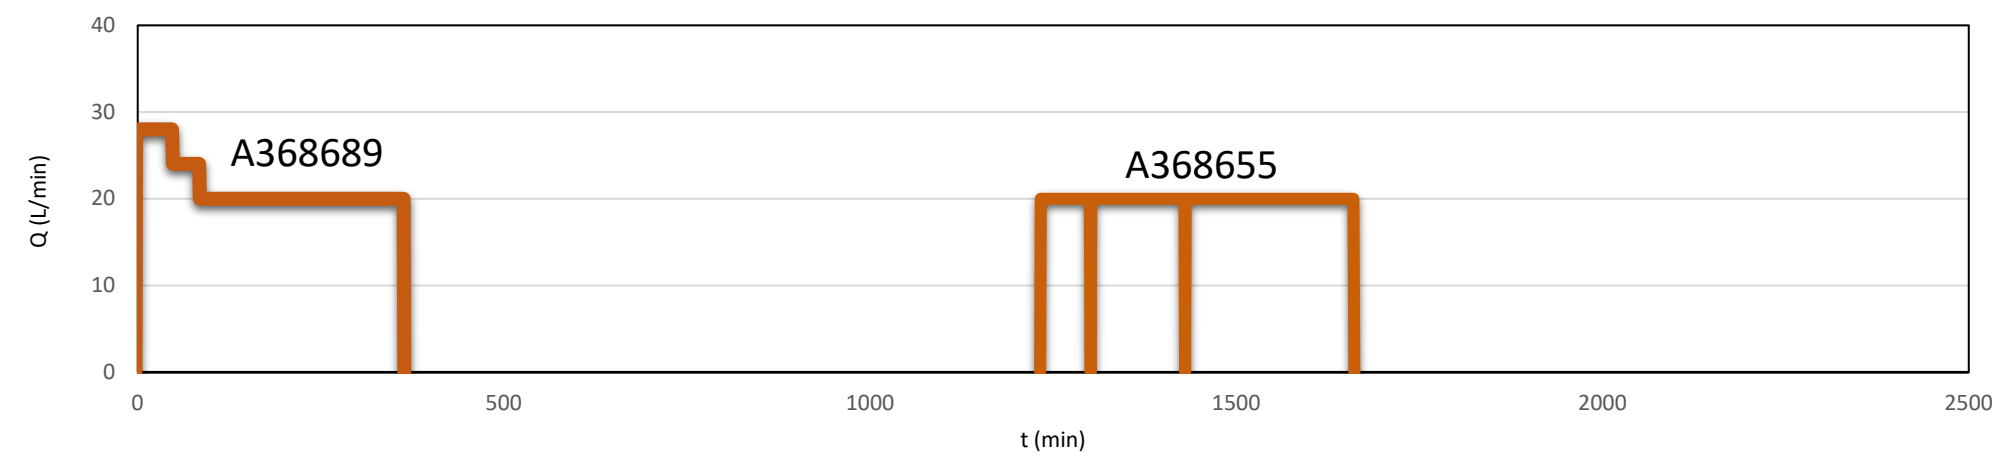
FIGURE 1:

- NOTES:
- 1) Testing carried out on July 31-August 1, 2023
 - 2) On-site pressure and temperature data collected using a Solinst Model 3001 datalogger transducer.
 - 3) Water level data is not corrected for fluctuations in barometric pressure.

WELL HYDROGRAPH – A368689 (TW 1)
JULY 31, 2023 – AUGUST 1, 2023

6-hour pumping tests were completed on wells A368689 and A368655 (Severance A and Severance B, respectively). The test on well A368689 took place on July 31, 2023 at 10:54 AM, and the test on A368655 took place on August 1, 2023 at 8:15 AM. A brief description of the test results is summarized in Table 3. Refer to Appendix B for hydrographs of each of the tests.

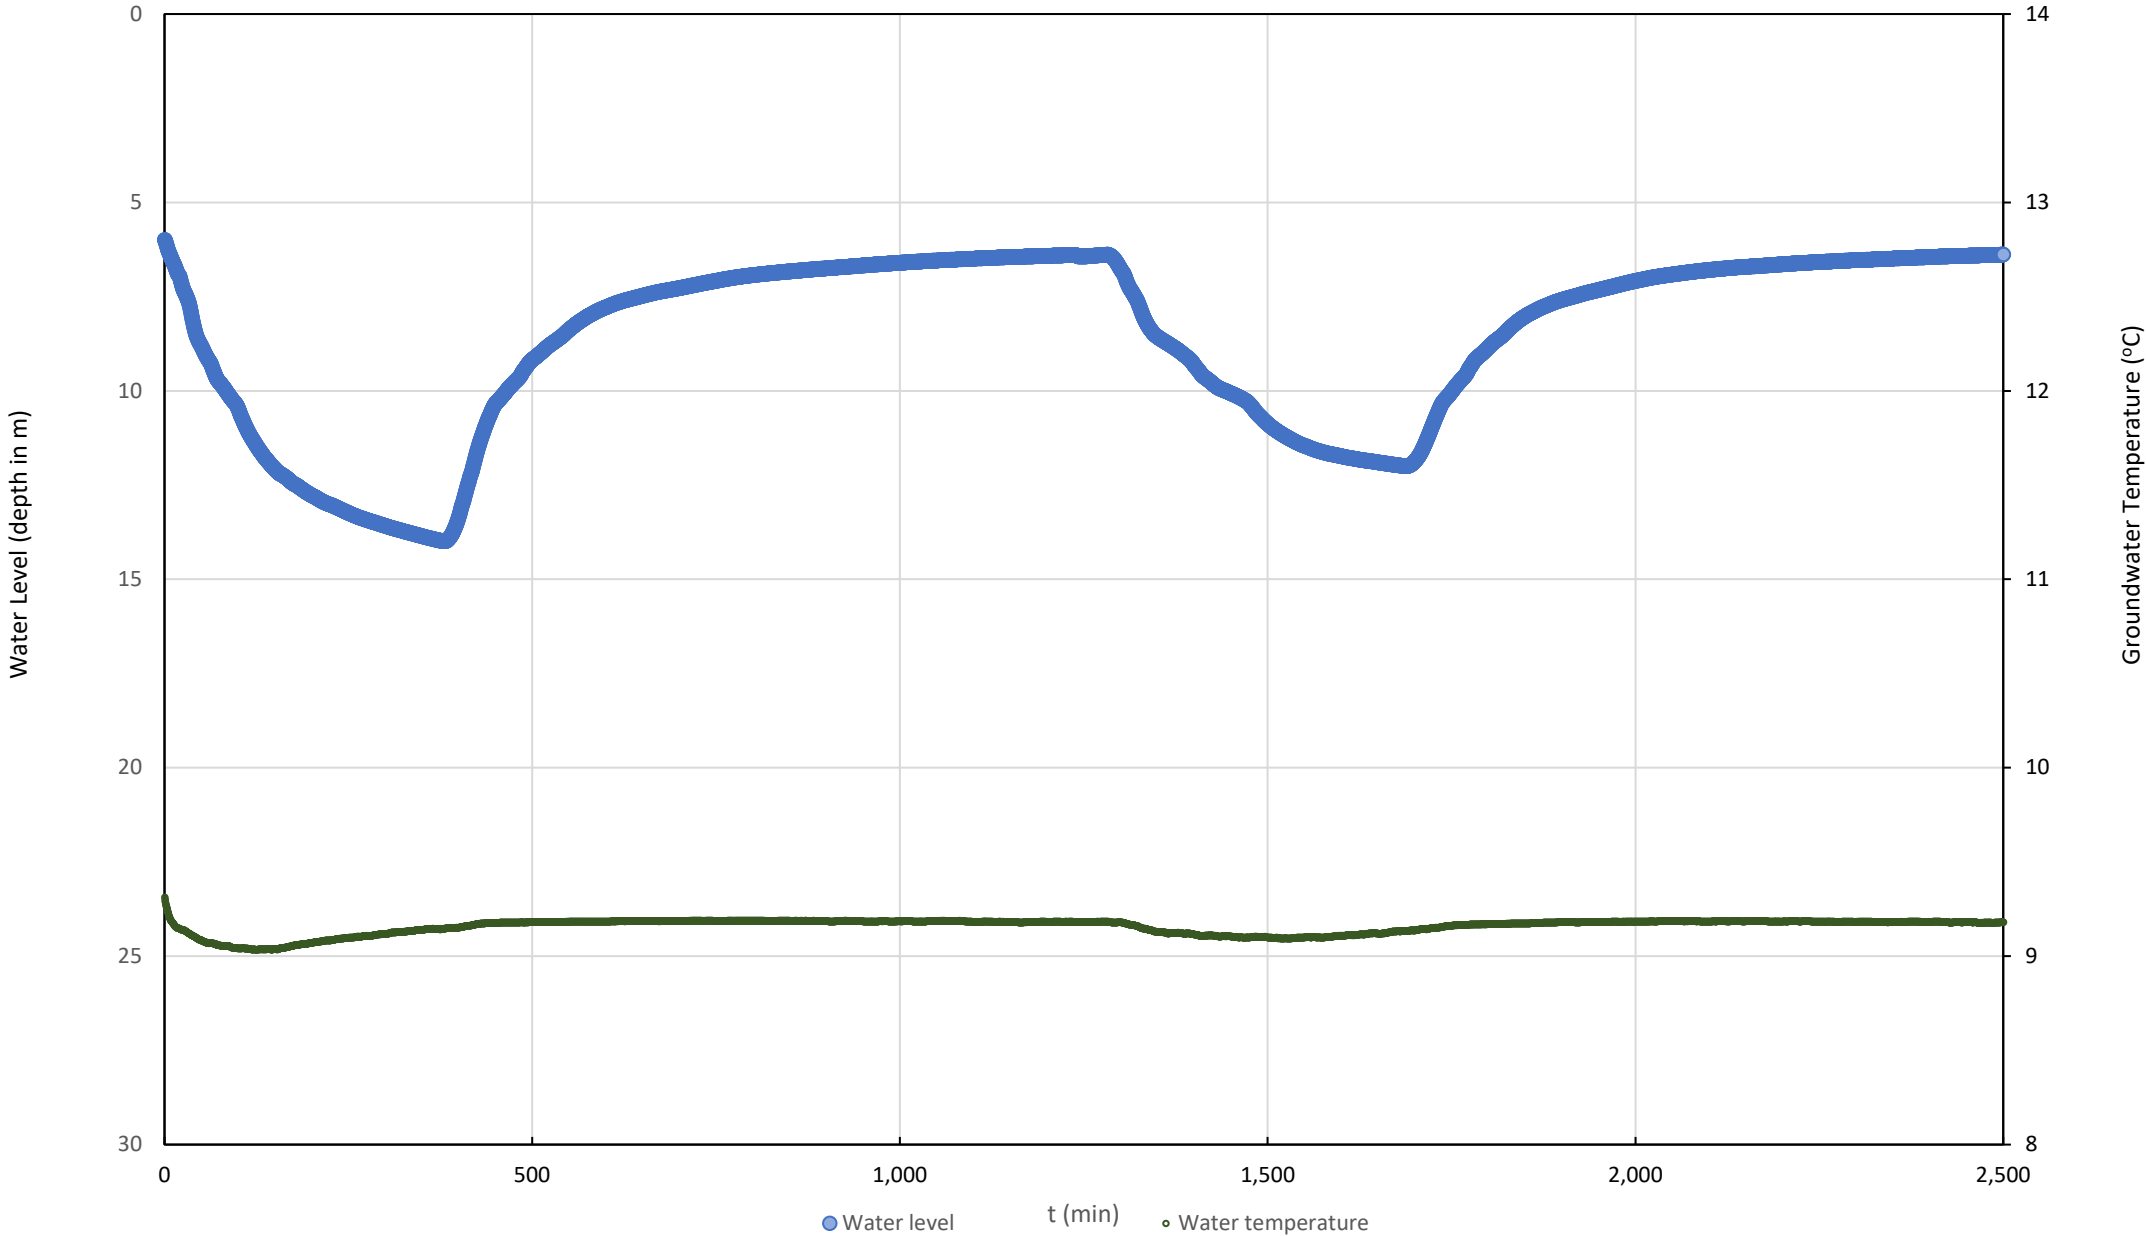
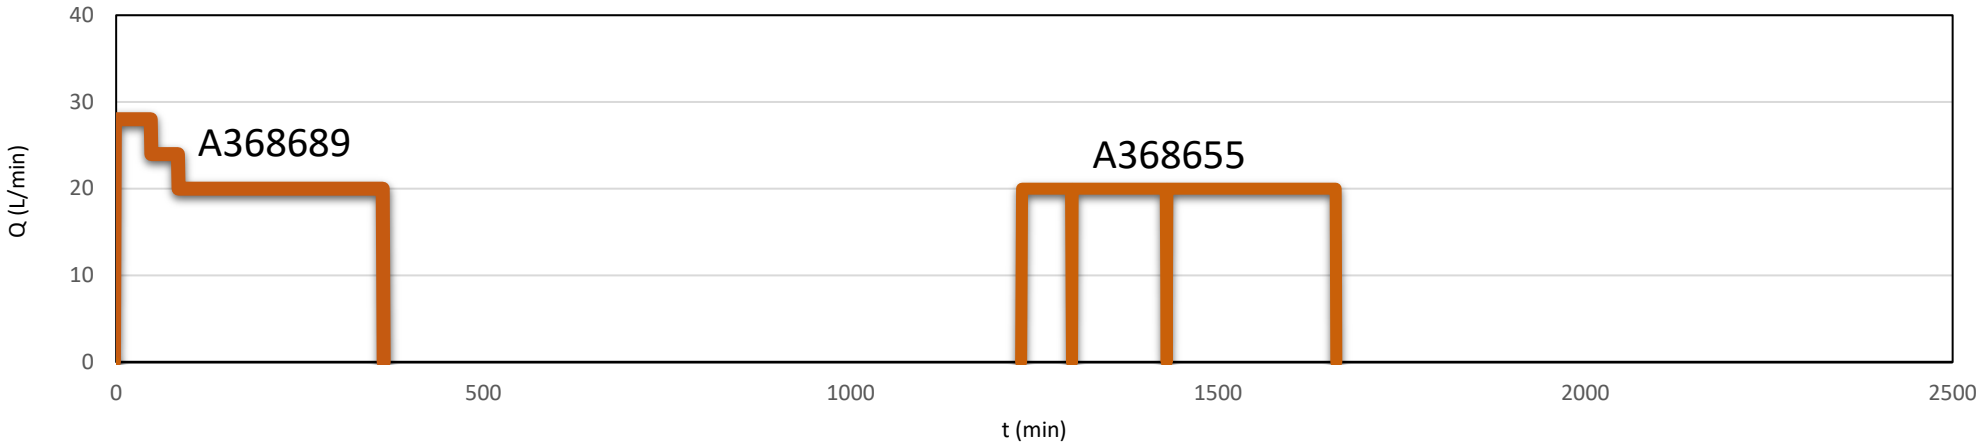
FIGURE 2:

- 1) Testing carried out on July 31-August 1, 2023
- 2) On-site pressure and temperature data collected using a Solinst Model 3001 datalogger transducer.
- 3) Water level data is not corrected for fluctuations in barometric pressure.
- 4) Temperature data for this graph was not accurate and was intentionally excluded.

WELL HYDROGRAPH – A368655 (TW 2)
JULY 31, 2023 – AUGUST 1, 2023

During the pumping test of A368655, the flow briefly stopped twice while adjusting the flow restriction valve, causing the water level to increase temporarily. For both wells, 70% recovery was observed to occur within an hour following the end of the pumping test, with full recovery occurring after about 10 hours.

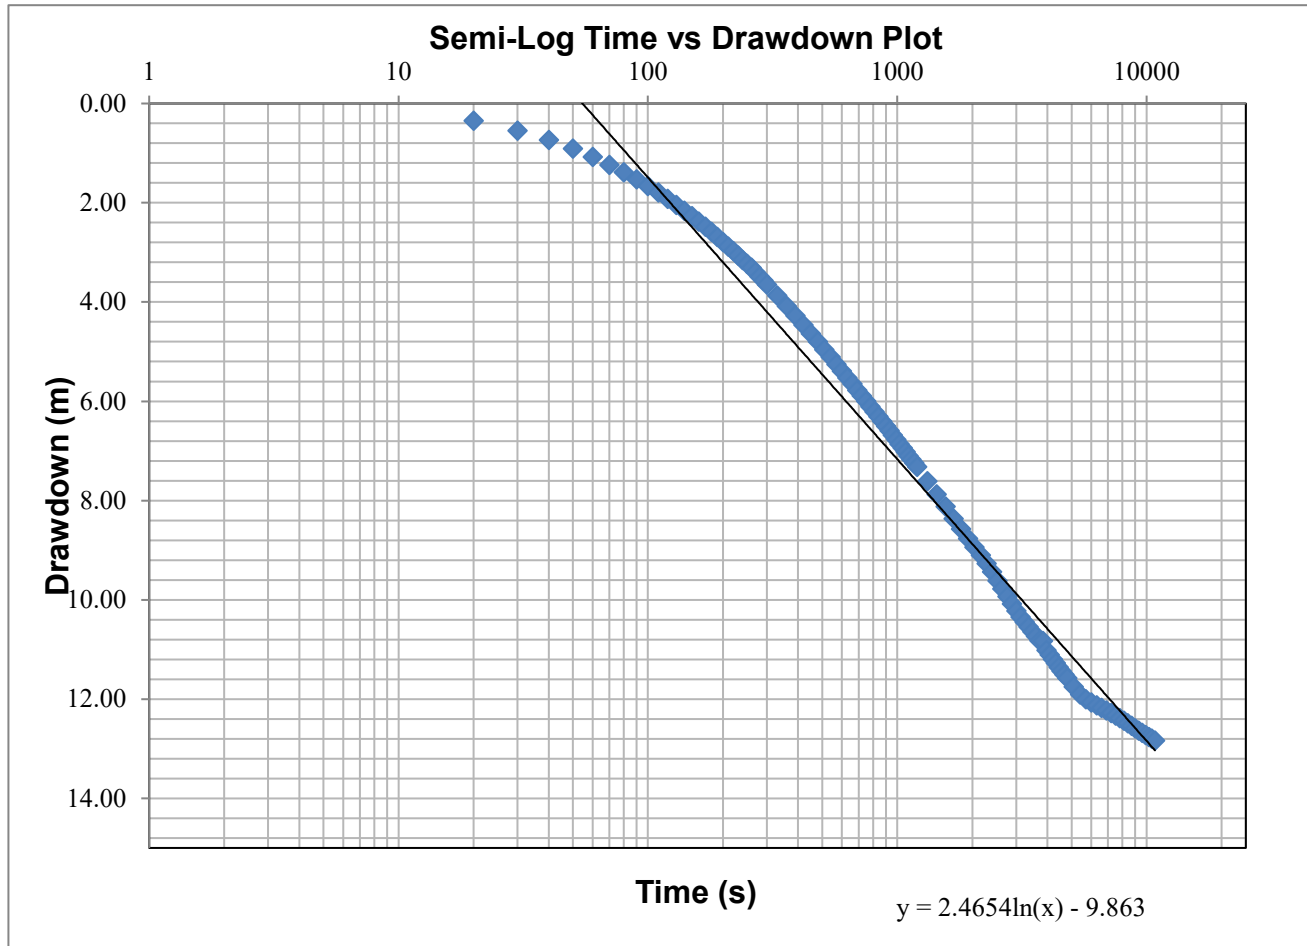
Cooper-Jacob Time Drawdown Analysis

Location : 287 Kelly Road
Client : Charles Kelly
Date of Test : July 31, 2023
Well ID : A368689

$$s = \frac{2.3Q}{4\pi T} \log_{10}\left(\frac{2.25Tt}{r^2S}\right)$$

$$T = \frac{2.3Q}{4\pi \Delta s}$$

Average estimated horizontal hydraulic conductivity values using the Dupuit-Forchheimer method are 4.7x10⁻⁶ m/s for A368689 and 2.8x10⁻⁶ m/s for A368655. The Ontario Soil Report #27 and well records in the area report clay loam in the overburden, so these values were compared with hydraulic conductivity values using the Cooper-Jacob Time-Drawdown method for confined aquifers. Estimated horizontal hydraulic conductivity values using the Cooper-Jacob method are 4.8x10⁻⁷ m/s for A368689 and 5.8x10⁻⁷ m/s for A368655. The time-drawdown graphs for the pump tests are included in Appendix D.

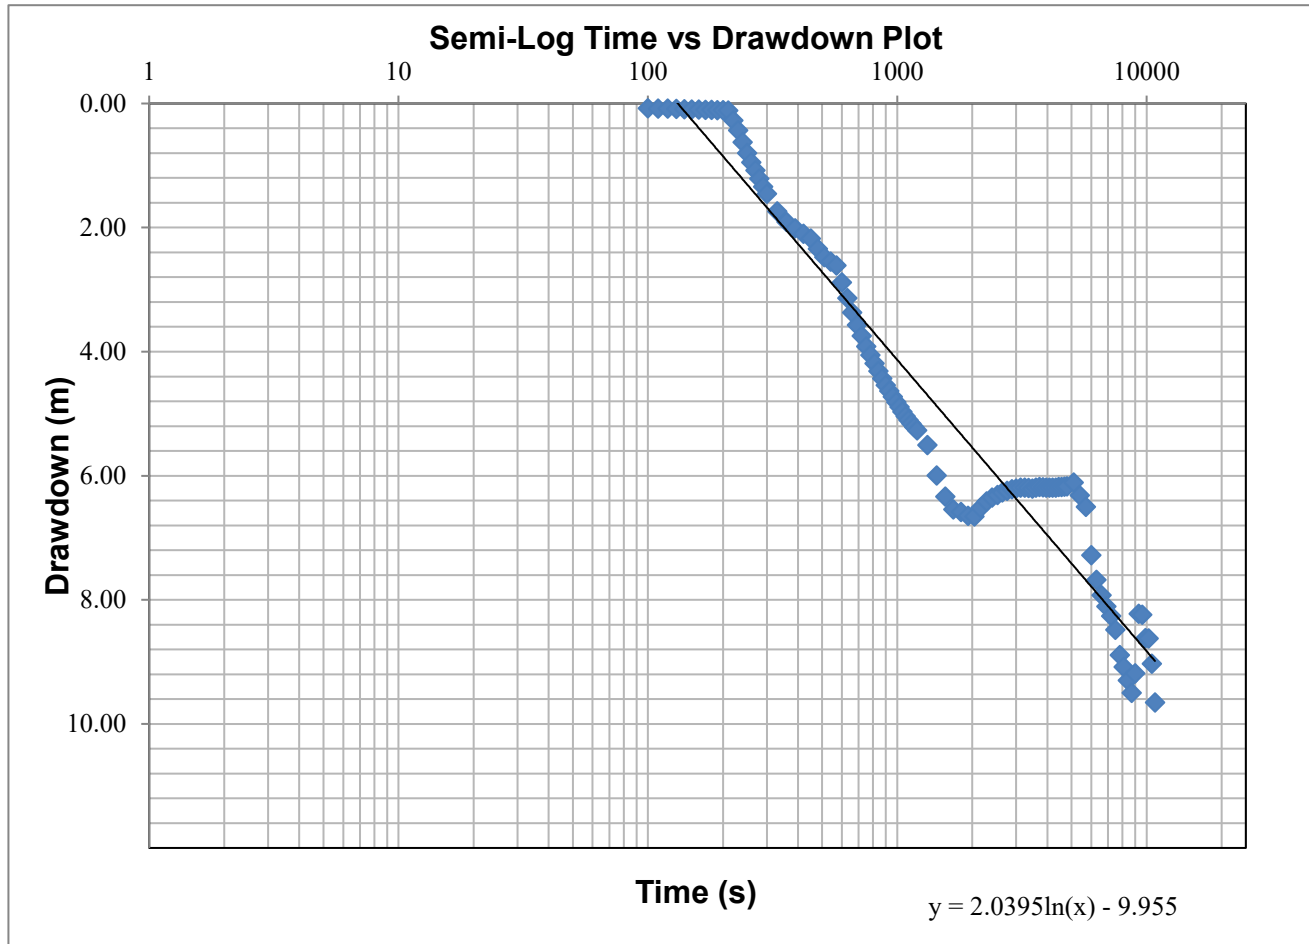
Cooper-Jacob Time Drawdown Analysis

Location : 287 Kelly Road
Client : Charles Kelly
Date of Test : August 1, 2023
Well ID : A368655

$$s = \frac{2.3Q}{4\pi T} \log_{10} \left(\frac{2.25Tt}{r^2S} \right)$$

$$T = \frac{2.3Q}{4\pi \Delta s}$$
