1100 Clearview Road Severance

Hydrogeology Study

1100 Clearview Road, Belleville, Ontario

Project # 25-6117A

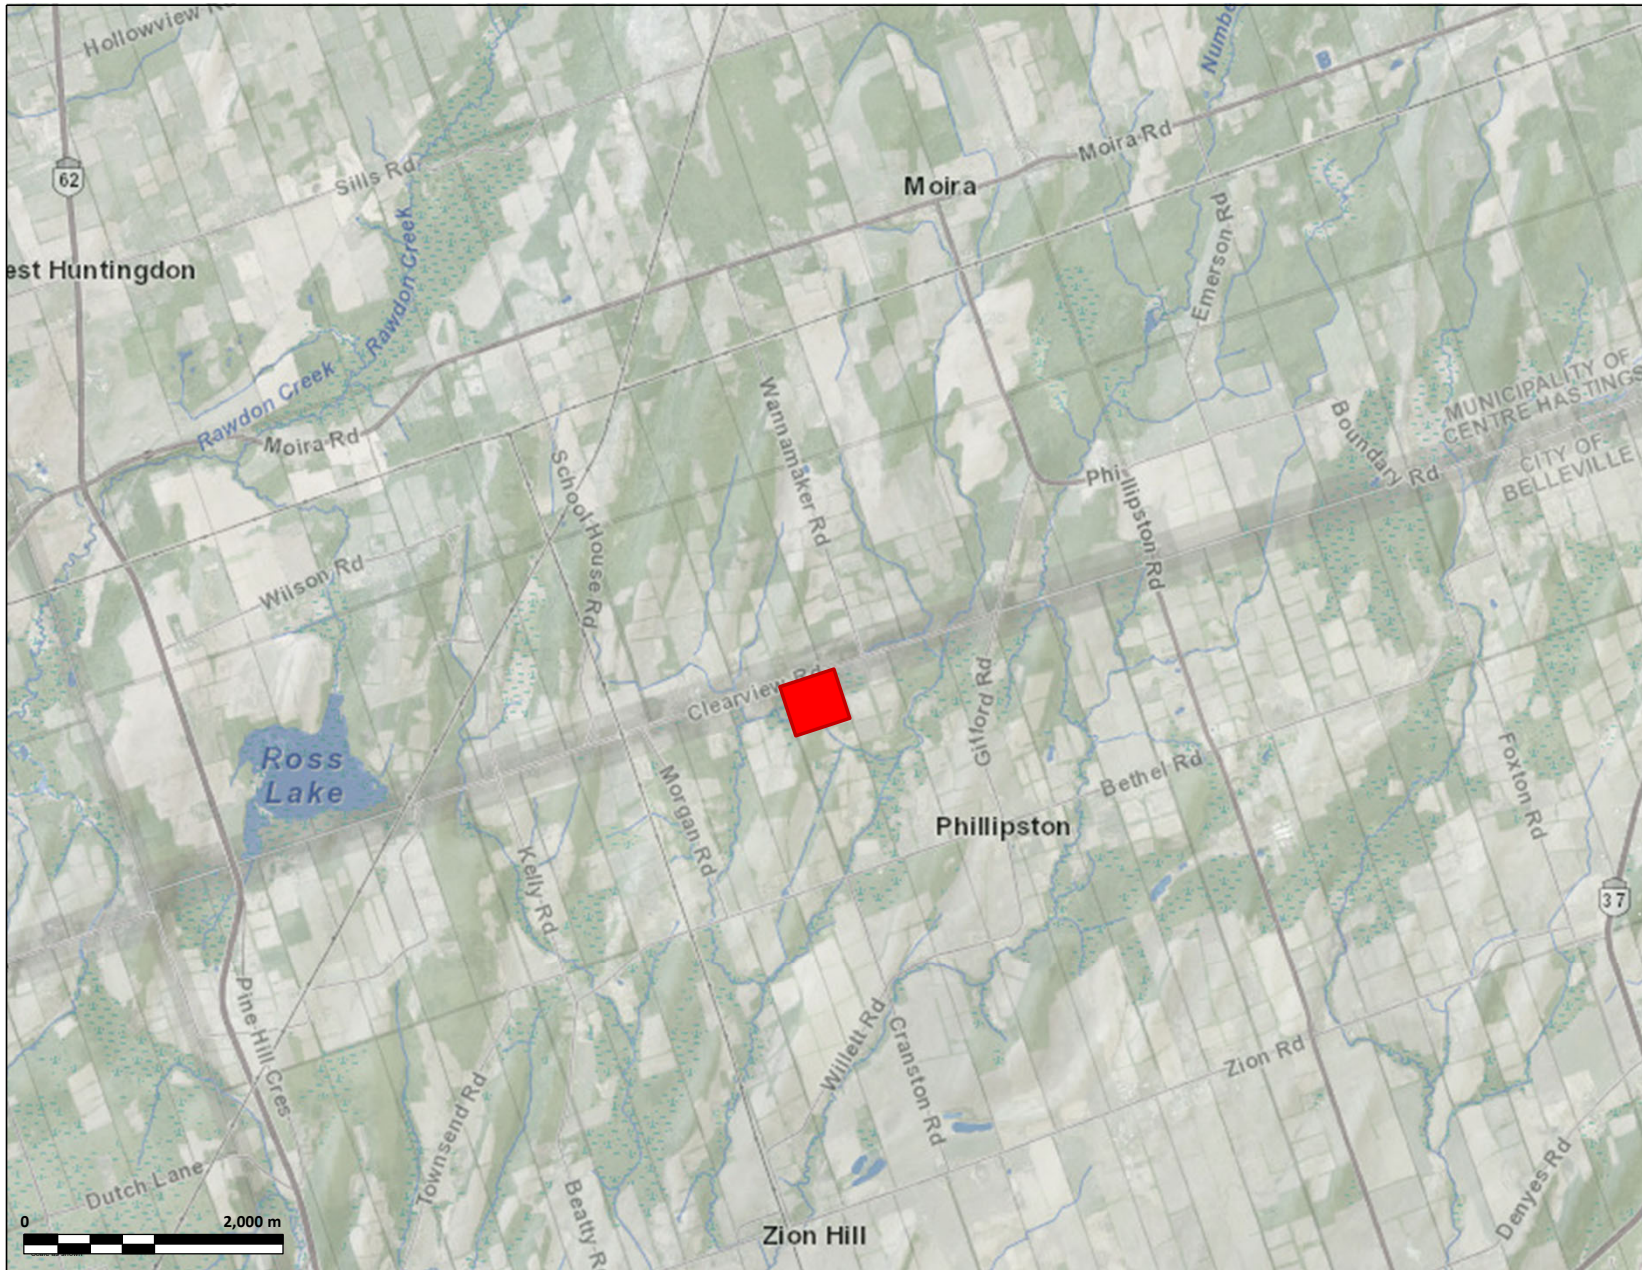
DRAWING 1:

SITE PLAN SHOWING PROPERTY LOCATION

The subject property covers an area of approximately 36.1 ha and is located at 1100 Clearview Belleville in the County of Hastings. The client wishes to sever a 1.3 ha and is current constructing a 2-bedroom residential dwelling with its own dedicated water supply well (A334393) and a proposed Class 4 Septic system. The retained lands feature 4 commercial buildings and are serviced by its own water supply (dug well) and Class 4 Septic System. The subject property is primarily grass covered where vegetation is present with the southern boundary and area surrounding the wetland treed. Local land use is Rural Residential and Agricultural. Maps of the property and its surroundings are provided in Drawings 1 and 2 (appended after text).

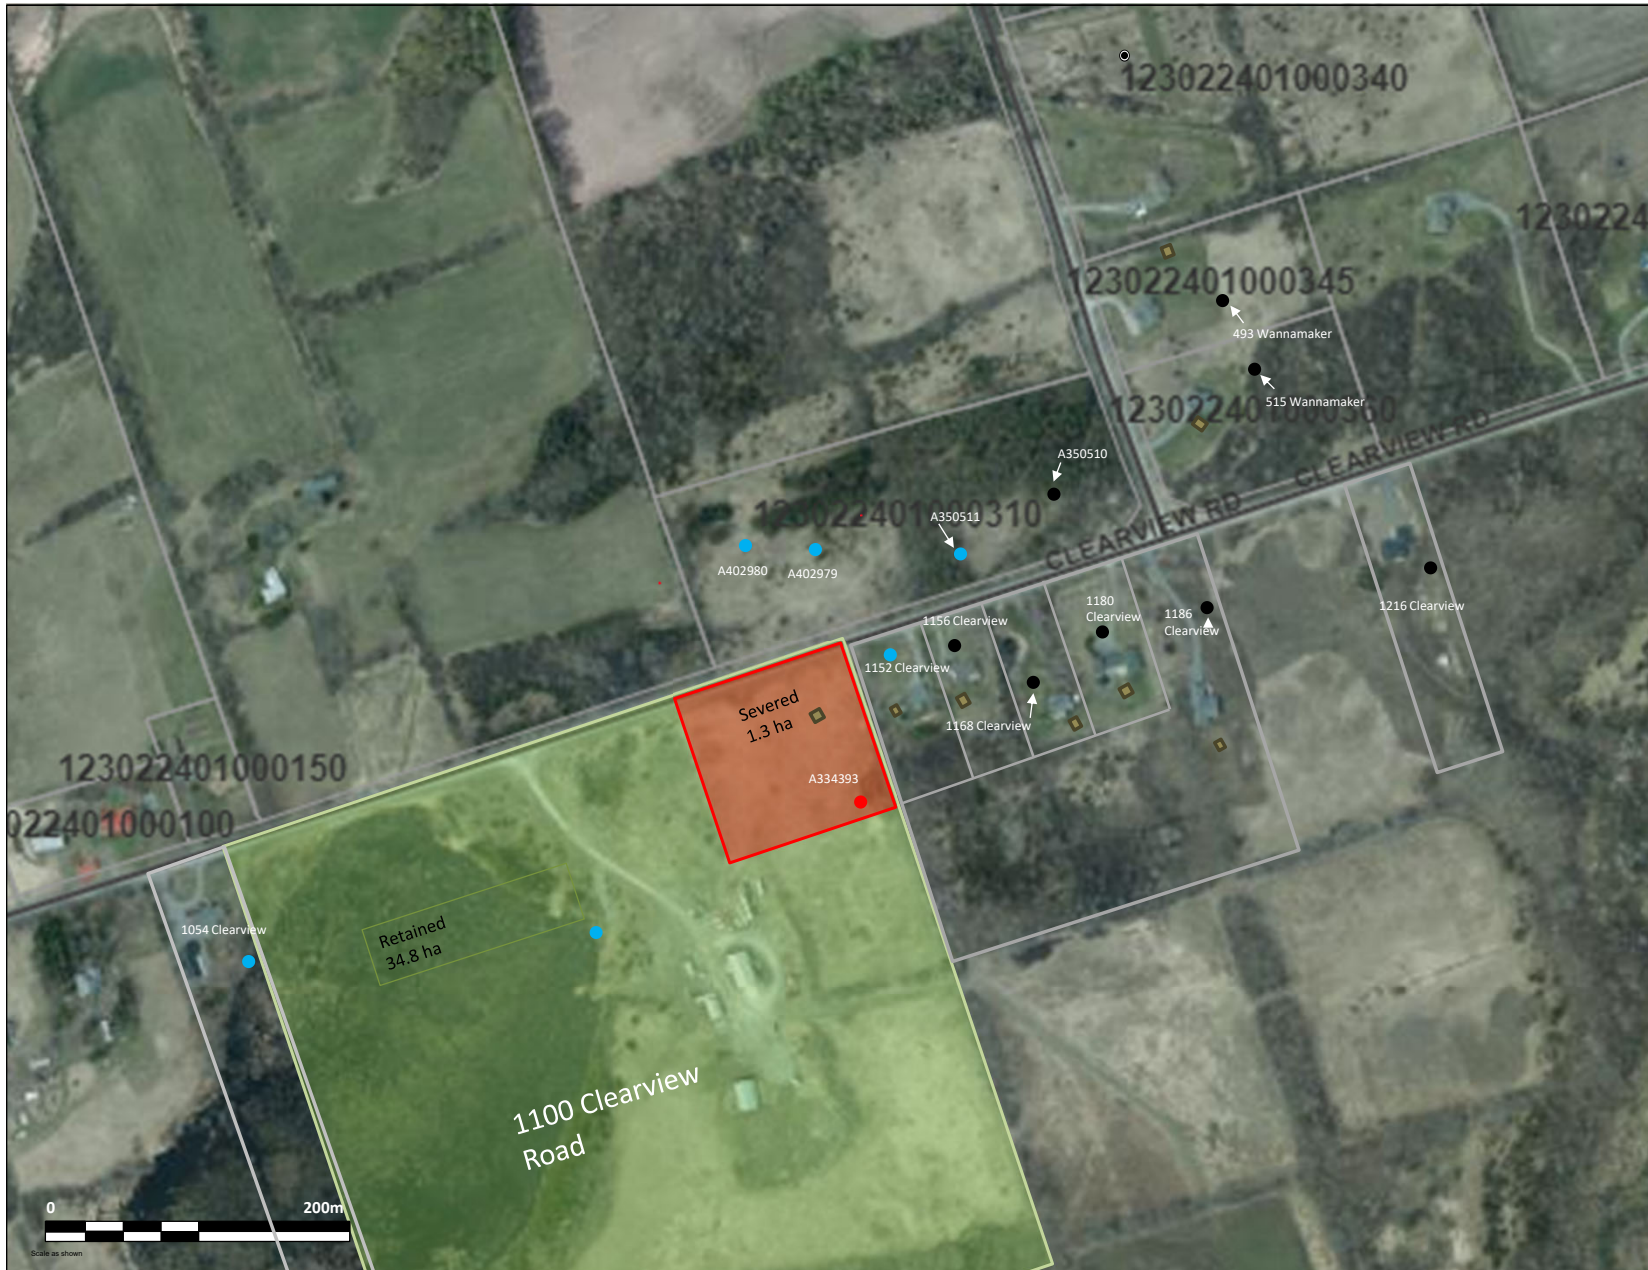
NOTES:
Base drawing and information obtained from the Hastings GIS
<https://hastings-gis.maps.arcgis.com/apps/webappviewer/index.html?id=4831ccb4e8bc4a90a83048982673340>

A search of the Ministry of Environment, Conservation and Parks (MECP) Well Record Database returned 18 wells within a 300 m radius of the site (see Drawing 2, appended). Four well records are for monitoring wells. Records in the vicinity indicate the bedrock in the area consists of Limestone 1.2 m to 9.1 m below ground surface (bgs) with a median of 2.1 m bgs. Drillers well tests show flows ranging from 4.5 L/min to 90.9 L/min and water found at depths ranging from 3 m bgs to 9.4 m bgs. Subject lands are located outside any mapped WHPA.

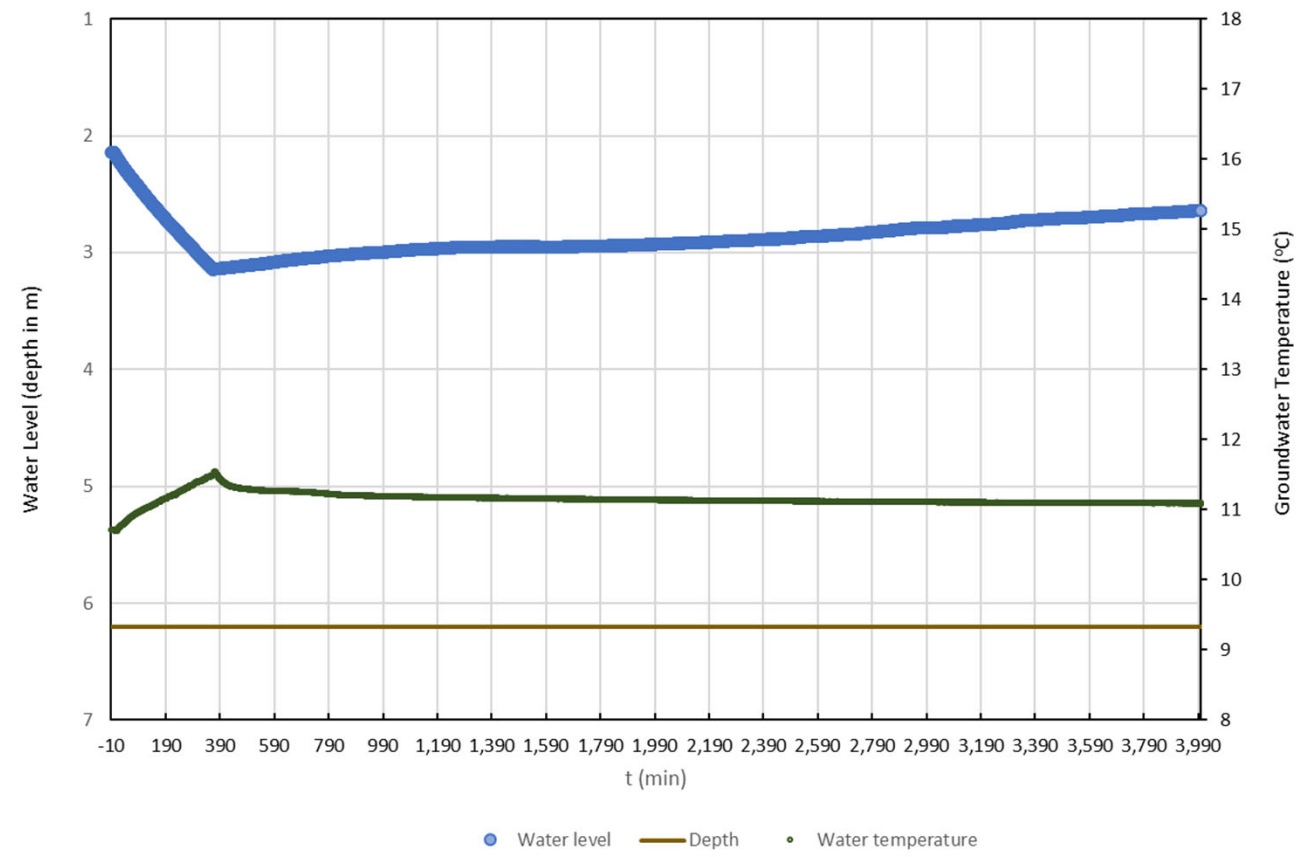
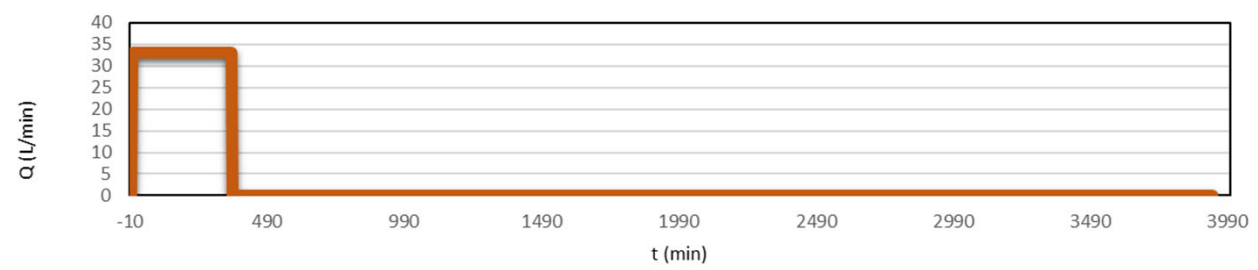
FIGURE 2:
WELL HYDROGRAPH – A334393 DRAWDOWN
OCTOBER 9, 2025

- 1) Quantity testing carried out October 9, 2025
- 2) On-site pressure and temperature data collected using a Solinst Model 3001 datalogger transducer.
- 3) Water level data is not corrected for fluctuations in barometric pressure.

The 6-hour pumping test was performed on October 9, 2025 using a submersible pump with the discharge routed through a flow restriction valve corresponding to the desired pumping rate. Discharge water was directed away from the well in a down gradient direction in the direction of the property boundary directly to the east.

A data-logging pressure transducer (Solinst Model 3001) was installed in the tested well as well as the large diameter well that services the existing commercial building as well as neighbouring wells at 1054, 1152, 1165 (3 wells monitored) Clearview Road. The datalogger in the test well was set to record at 10-second intervals. Hydrographs are provided in Appendix B.

A pumping test was performed on the drilled water supply well A334393 at 11:01 AM October 9, 2025 during warm and dry conditions. A total 0.9 mm of precipitation fell in the two weeks leading up to the date of the pumping test. The static level was measured as 2.21 m bgs prior to commencing the pumping test.

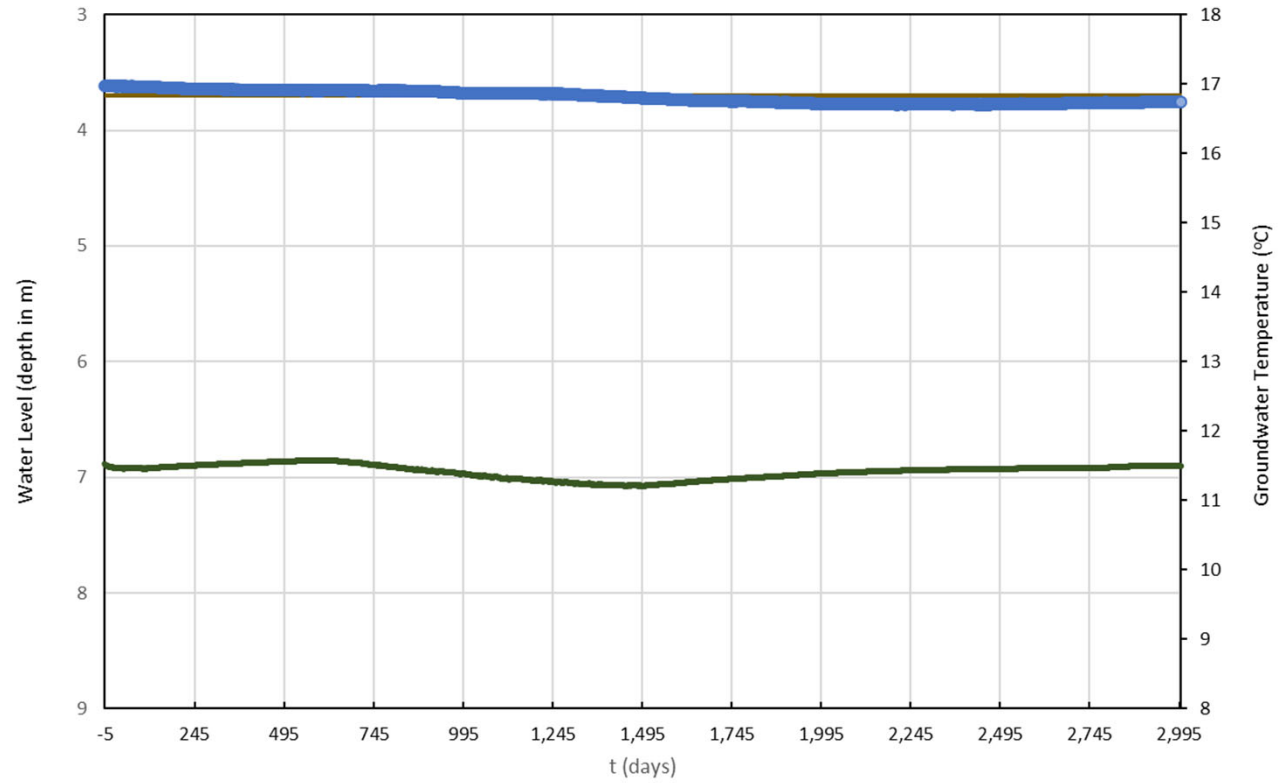
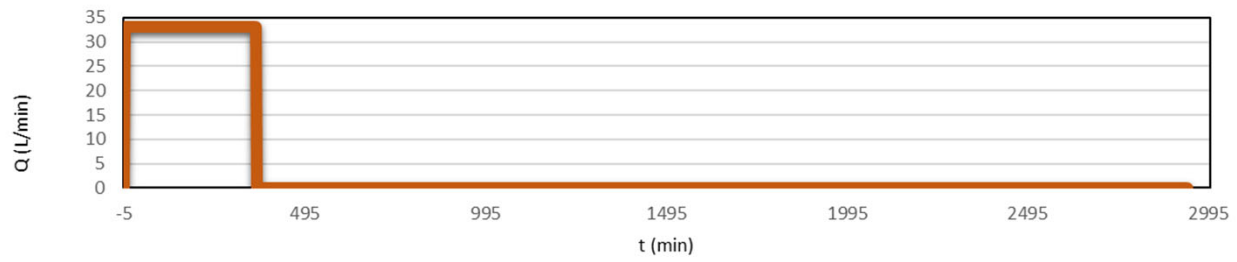
FIGURE 7:
WELL HYDROGRAPH - A402979
OCTOBER 9, 2025

- 1) Quantity testing carried out October 9, 2025
- 2) On-site pressure and temperature data collected using a Solinst Model 3001 datalogger transducer.
- 3) Water level data is not corrected for fluctuations in barometric pressure.

● Water level — Depth • Water temperature

No observable interference caused by the 6 hour pumping test was noted at any of the monitored wells during the 6 hour pumping test (i.e., 1165 (3 wells), 1152 and, 1054 Clearview Road, as well as the existing well at on the retained lands of 1100 Clearview Road). It should be noted that there the well at 1152 Clearview was used frequently during the period of the 6-hour pumping test but recovery that occurred during the testing period within the well was consistent with other instances of recovery throughout the monitoring period.
